Allied Home Inspections

INSPECTION CONDITIONS

BUILDING TYPE: 1 family, Cape Cod.

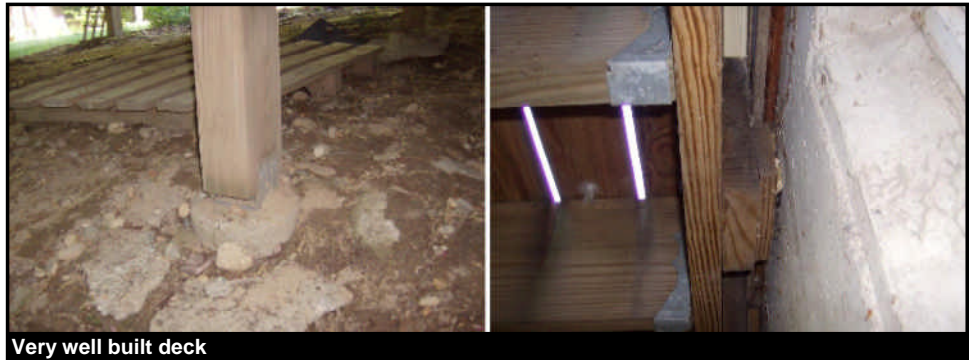
DECKS:

Appears serviceable, very well built & properly supported / attached to house by a blocking system that allows water to pass by.

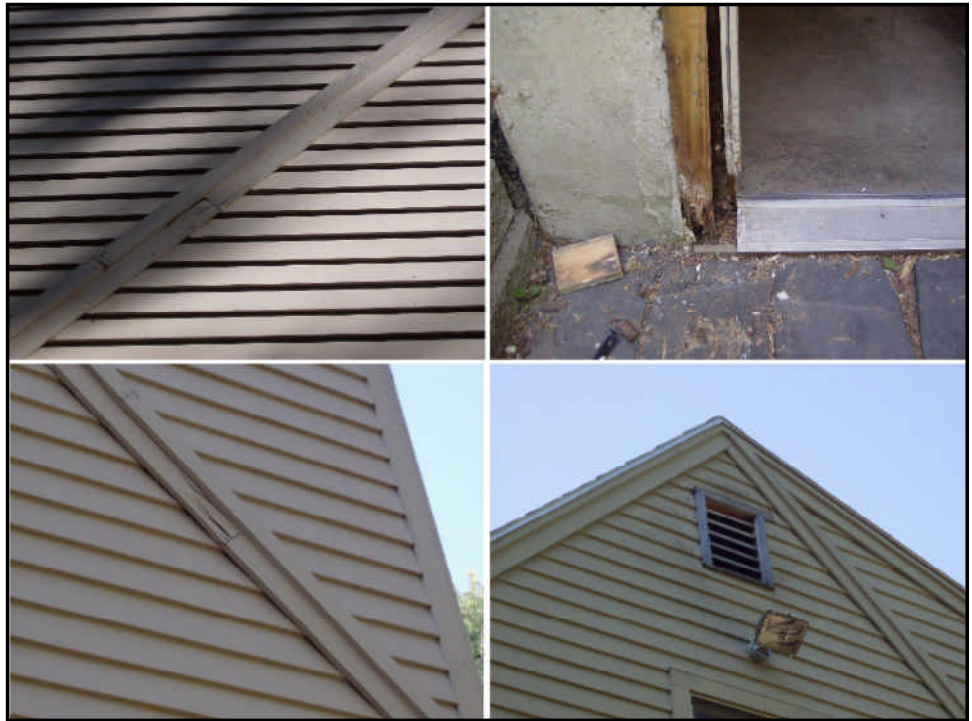
TRIM:

Appears serviceable, Loose or deteriorated material-water damage left side gable facia- rear basement door being repaired. Bottom dormer

window trim.

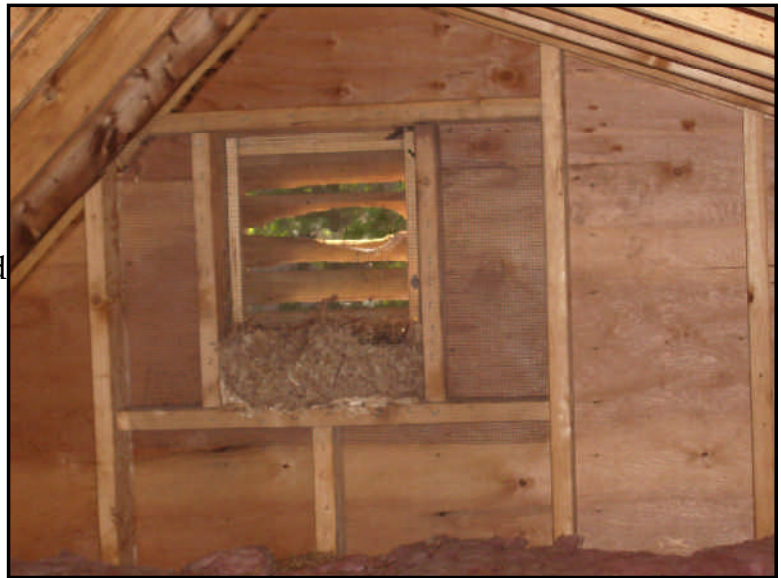
ATTIC AND INSULATION:

Attic is partial, Conventional framing, Viewing was limited, to observing from hatch areas only. Access is restricted by low headroom or stored goods. Minor stains are noted, Ventilation is provided - repairs needed on gable end vent. Remove debris.

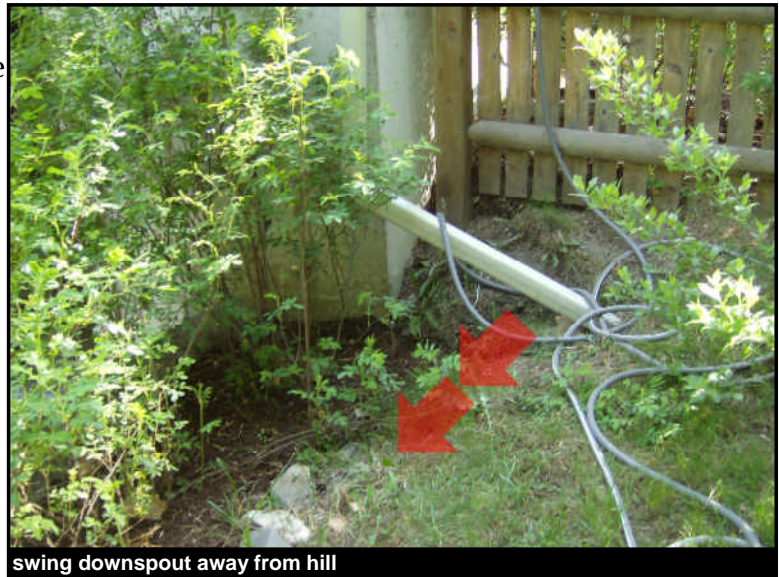
GUTTERS & DOWNSPOUTS:

Full, Appears serviceable. Route downspouts away from the building.

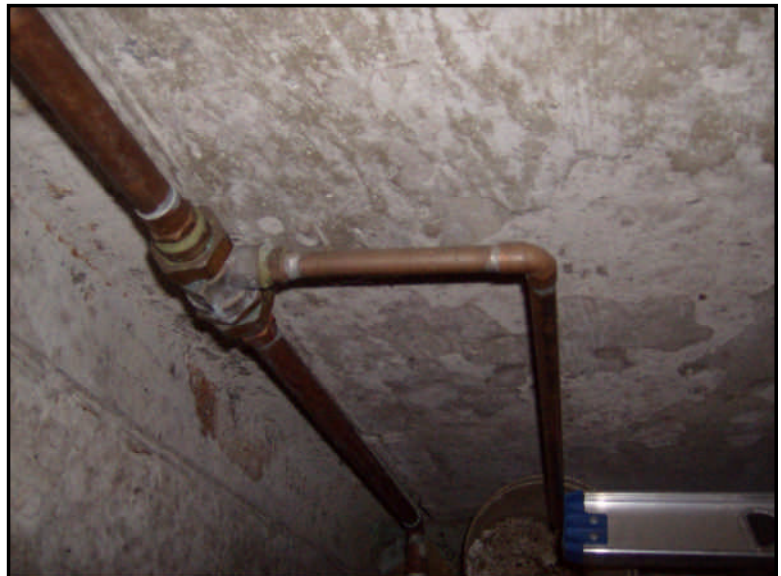
MAIN LINE:

CONDITION: Water meter is located, at the east side of the house. Appears serviceable, Main line is 3/4 inch diameter, Water pressure appears adequate-small discharge from back flow preventer.

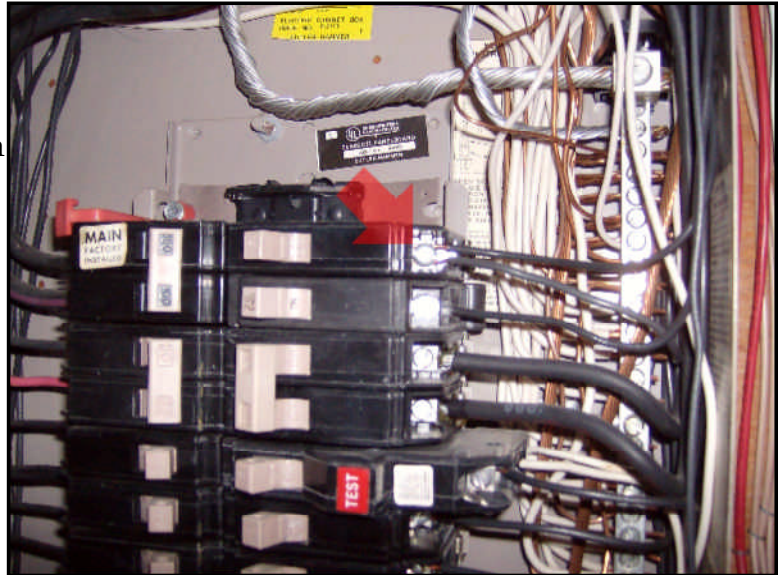
ELECTRICAL PANELS:

Circuit and wire sizing correct so far as visible, Grounding system is present, Multiple wires are connected to a single lug on a circuit breaker where only one wire should be connected, BRANCH CIRCUIT PANEL- MULTIPLE

CONNECTIONS NOT APPROVED: A double lead is the connection of two wires (circuits) to one circuit breaker. Because the amperages are minimal in this case, the problem is considered minor. Nevertheless,

the next time the electrician is out for other work, have modifications made so each circuit has its own circuit breaker. Knock-outs missing at panel-insert plastic snap in plugs.

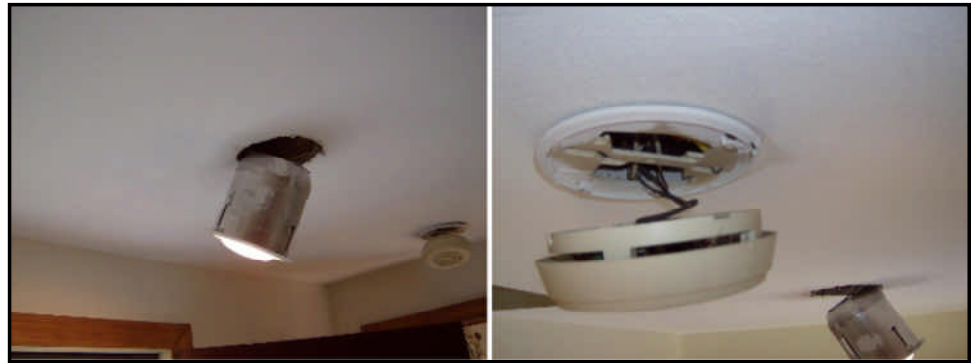
**BRANCH
WIRING:**

Copper, Appears serviceable, Cables inadequately attached or protected- smoke detectors circuit. Front hall fixture.

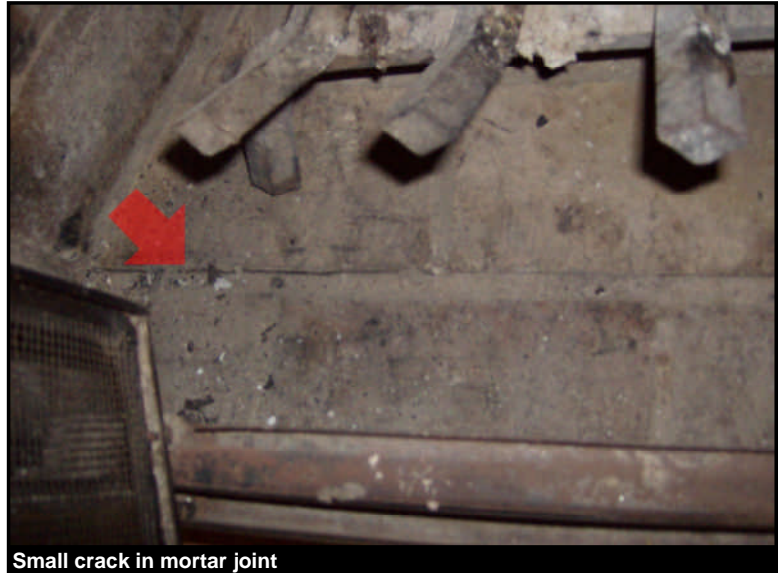
FIREPLACE/WOOD BURNING DEVICES:

CONDITION: Masonry, Mortar joints are deteriorated, Recommend cleaning and inspection before use.

Small crack in mortar joint
